## **ULTRASONIC EXAMINATION SYSTEM TO SHOW DANGEROUS CRACKS ON CERAMIC POST INSULATORS STRUCTURE**

**Key words:** ultrasonic control, ceramic cylindrical post insulators, disconnecting switches.

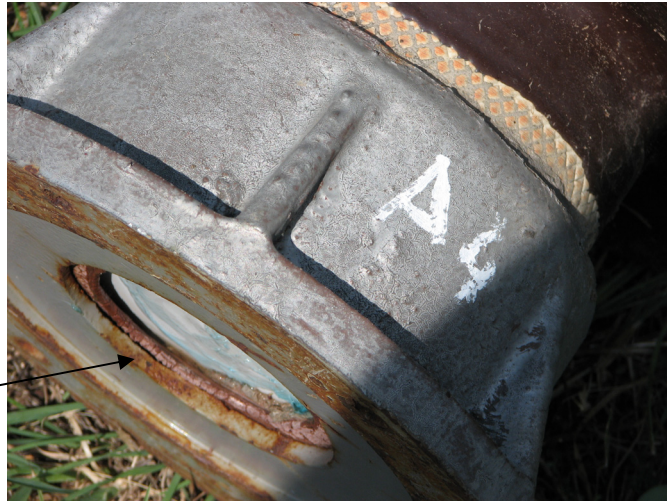
Zonă  
palpare

In the next phase, there have been examined the inferior zone, through the metallic cup hole, as is presented in Fig.2.1 .

Fig.2.1. Examination zone on the base of Ceramic Post Insulator.

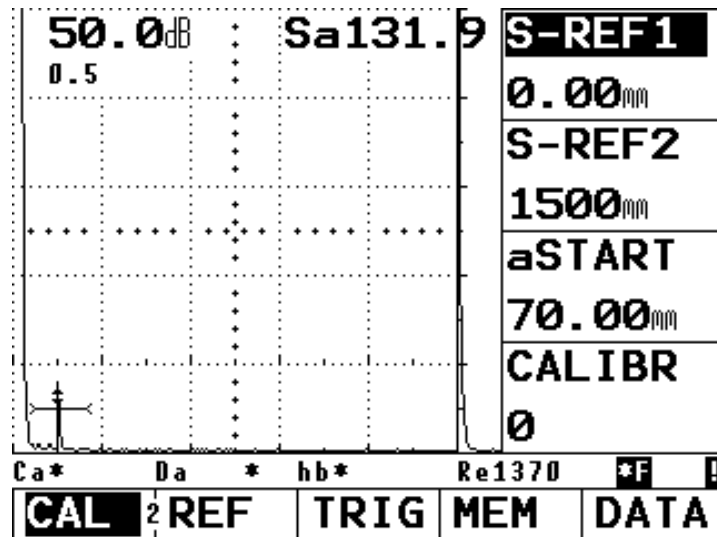
There have been found “discontinuities indication”, as they are signalized in the following diagrams (DAC –Distance Amplitude Curve ) in Fig.2.2, Fig.2.3, Fig.2.4. ,

for the most part at the bottom of the ceramic body, covered by metallic cup, but also along the ceramic body and at the top of it.

Fig. 2.2. Discontinuity indication at 131.9 mm

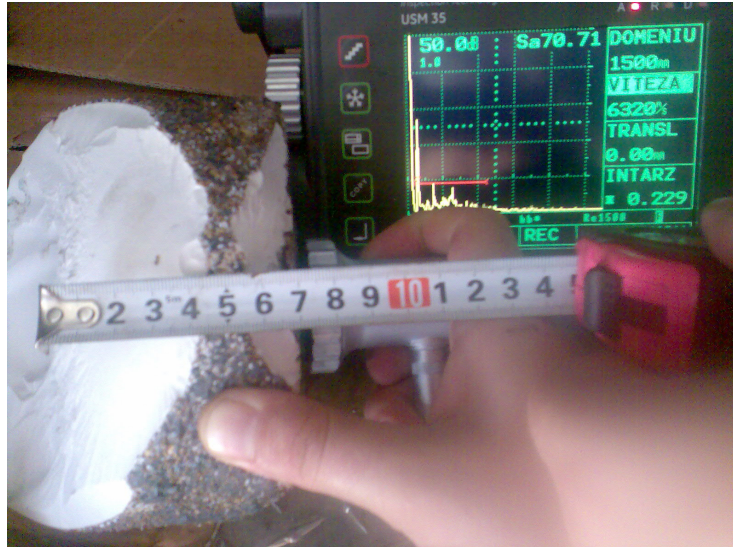
In Fig.2.5. is presented a direct confirmation of the discontinuity indication presented by DAC diagram in Fig.2.4.

**Fig. 2.5. Confirmation of the discontinuity indication at 70 mm.**
